**CITY OF BALTIMORE WET WEATHER CONSENT DECREE
SMOKE AND DYED WATER TESTING FORM**

Sewershed: JONES FALLS

Manhole ID: S31QQ_028MH

Test ID: 0994-386

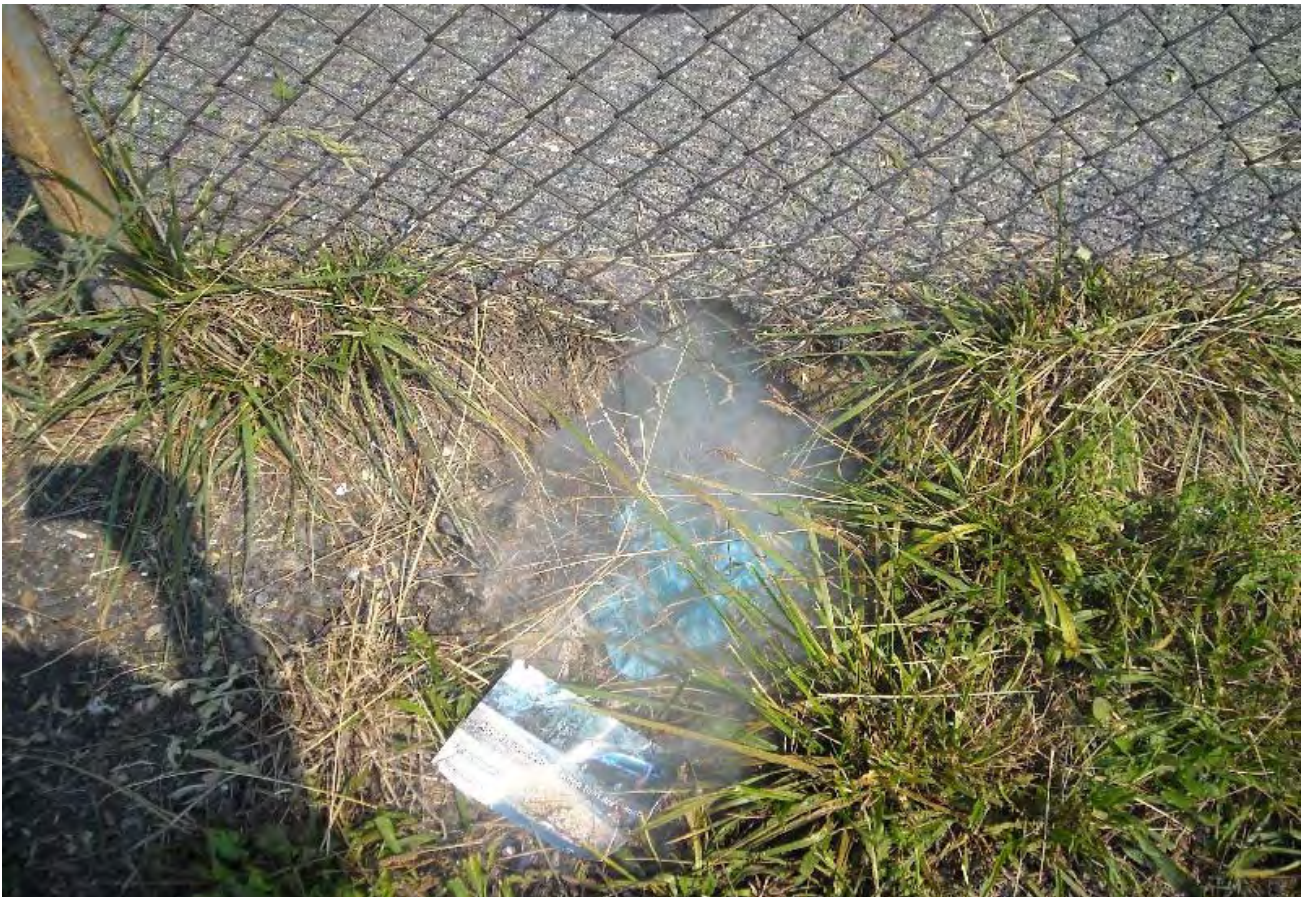
Photograph No: OB01-01
Filename: 0994-386_OB01-01.jpg

Unique Test ID: 386	Date: 07/18/2008	Basin: JF-19
Defect No: OB01-01	Supervisor: E.R.	Dye Test Recommended: N
Address: 401 W. 26TH ST.		
Source Type: 16	Location: 14	Severity: 03
Sector: 02	Drainage Area: 10	
Comments: SMOKE IS COMING FROM HOLE IN GROUND IN UNPAVED PARKING LOT AT ADDRESS. DEFECT IS ALONG THE NORTHERN FENCE ADJACENT TO MAIN SEWER LINE

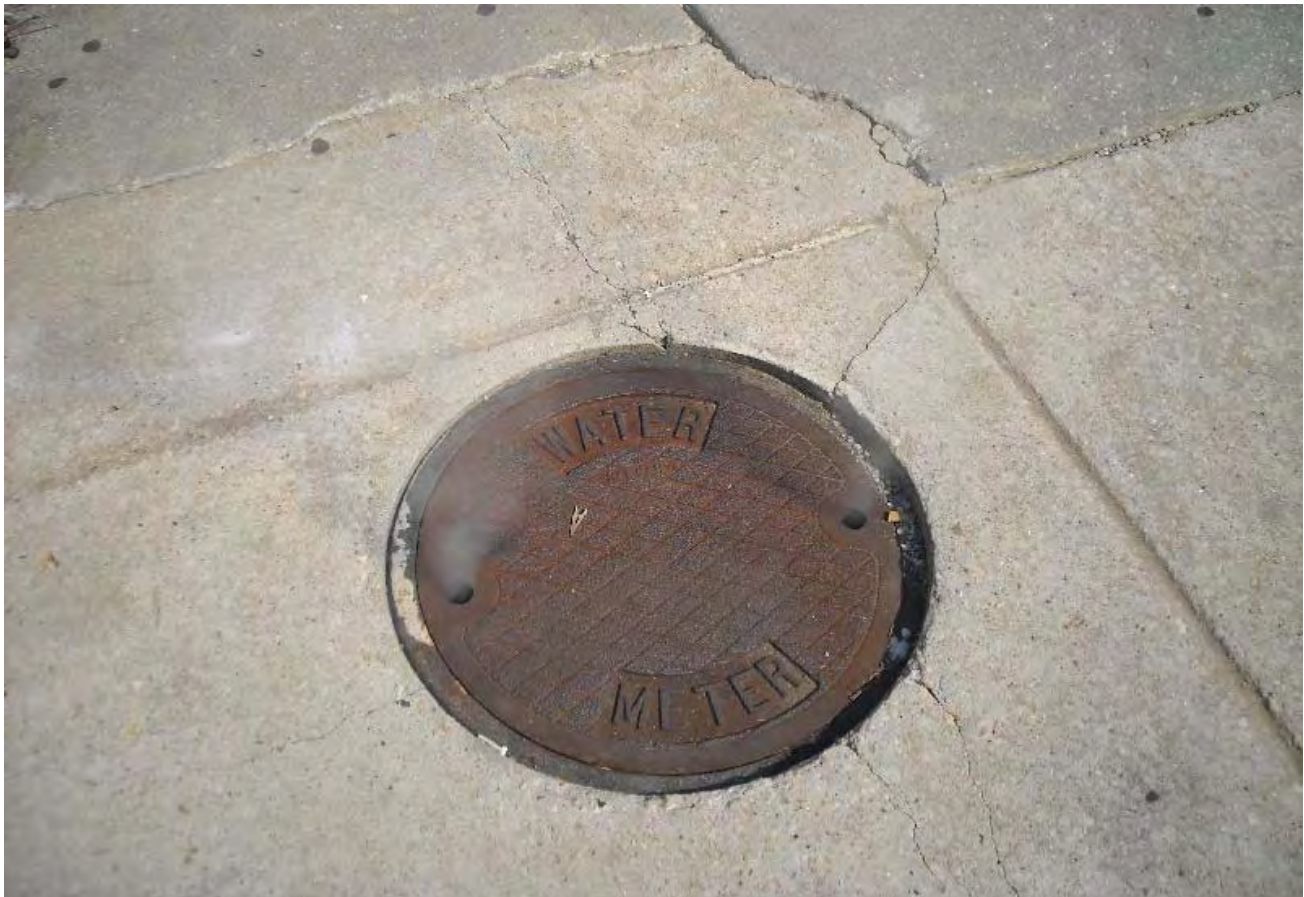
Photograph No: OB02-01
Filename: 0994-386_OB02-01.jpg

Unique Test ID: 386	Date: 07/18/2008	Basin: JF-19
Defect No: OB02-01	Supervisor: E.R.	Dye Test Recommended: N
Address: 401 W. 26TH ST.		
Source Type: 16	Location: 05	Severity: 03
Sector: 01	Drainage Area: 6	
Comments: SMOKE IS COMING FROM WATER METER ACCESS IN FRONT OF ADDRESS ENTRANCE
